2017 Hurricane Harvey Deployment  
Arkema Facility Response

***2017 ASPECT Preliminary Report  
Arkema Plant Response  
Crosby, TX***

***August 31, 2017  
0600 hrs to 0845 hrs***

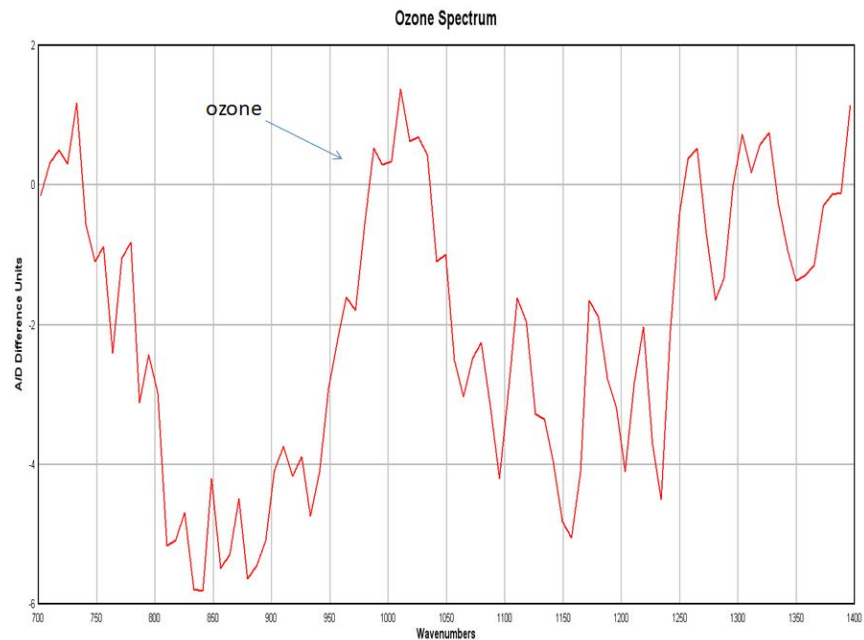
Commonly occurring air pollutants such as ozone and PAN (Peroxyacetyl nitrate) are being detected which confirms that the FTIR spectrometer is operating properly. Spectra images of these constituents are shown in Figures 4 & 5.

Figure 4: Passive (remotely detected at 2,800 ft AGL) FTIR spectra showing ozone, a commonly occurring air pollutant. This confirms that the instrument was operating properly.

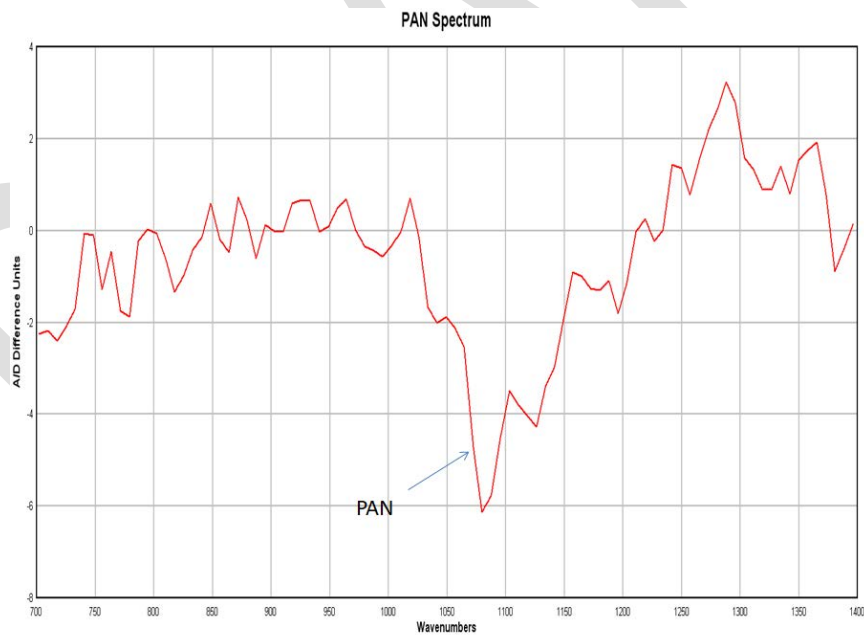
Figure 5: Passive (remotely detected at 2,800 ft AGL) FTIR spectra showing PAN (Peroxyacetyl nitrate), a commonly occurring air pollutant. This confirms that the instrument was operating properly.
